## PROPERTY CONDITION ASSESSMENT

at  
**Green Island Trading Company**  
**38 Metropolitan Road**  
**Toronto, Ontario**

CCIG Project No: T1611742CA

August 30, 2016

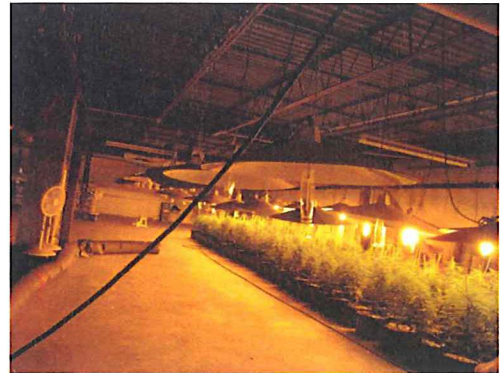
- .1 General view of the second floor of the north section that is currently occupied by Green Island Trading Company. Minimal finishes are installed within the space. The floor is formed by exposed concrete and a waterproofing system is not installed over the top surface of the floor slab.

A waterproofing system is required at the floor slab of the second floor tenant space to prevent the entry of water into the exposed concrete floor slab. Water that penetrates the floor slab may cause corrosion of the underlying steel deck and supporting structure.

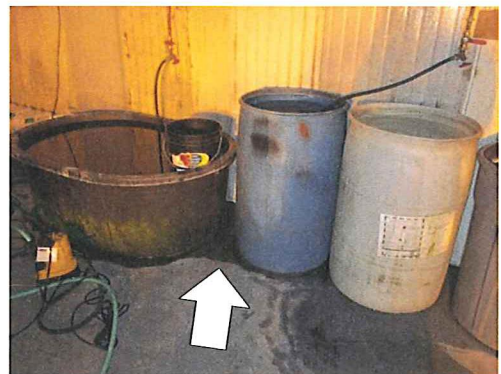
- .2 Water from storage tanks on the second floor level spills onto the concrete floor slab. Water may penetrate the concrete slab and cause corrosion of the underlying steel deck and supporting structure.

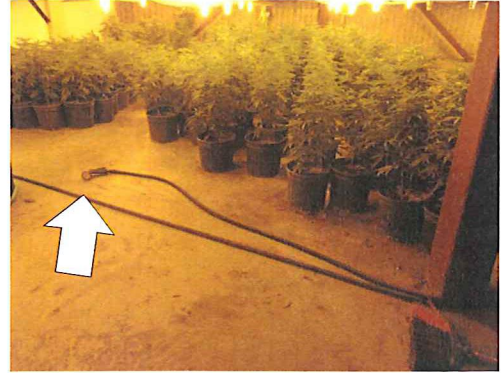
- .3 It appears that water is sprayed directly onto the plants and floor slab using a garden hose. Water may penetrate the concrete slab and cause corrosion of the underlying steel deck and supporting structure.

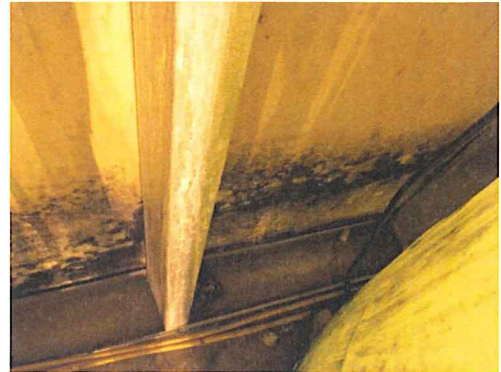
- .4 There are black stains (likely mold) on partition walls within the 2<sup>nd</sup> floor tenant space, particularly near the base of the walls.

In our opinion, the current condition of the second floor tenant space occupied by Green Island Trading Company does not meet the requirements detailed in Section 629-6 of the Toronto Municipal Code.

- Sample the areas of black stains within the tenant spaces and carry out laboratory analysis to determine if mold is present, and
- Clean the areas of black stains from the surfaces within the tenant spaces. Cleaning procedures are dependent on the results of the laboratory analysis.

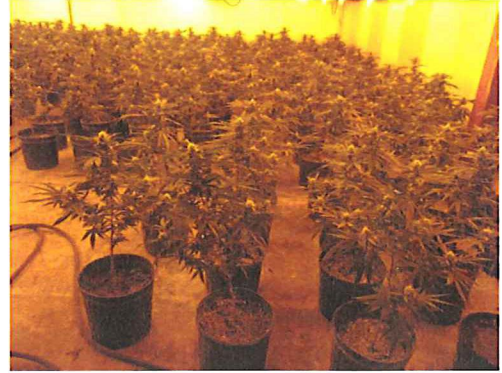
- .5 General view of the east side of the centre section of the building (ground floor level) that is currently occupied by Green Island Trading Company. Minimal finishes are installed within the space.

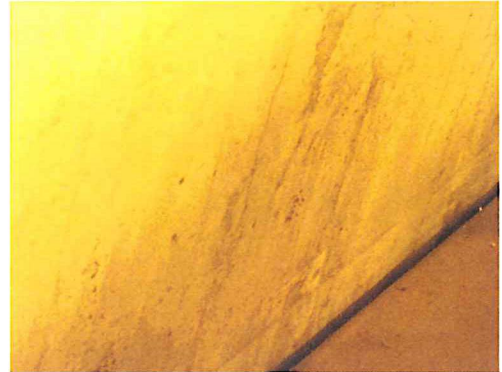
- .6 There are black stains (likely mold) on the freezer panels of a decommissioned walk-in cooler within the ground floor space occupied by Green Island Trading Company.

In our opinion this condition does not meet the requirements detailed in Section 629-6 of the Toronto Municipal Code.
