3.0 STRUCTURAL FRAMING

PROPERTY CONDITION ASSESSMENT

Green Island Trading Company, 38 Metropolitan Road, Toronto, ON

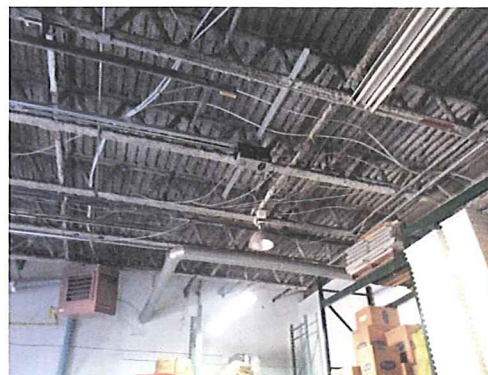
- .1 General view of the underside of the second floor framing at the north section as viewed from the Cool Ocean Impex Inc. space. Structural framing members are covered with spray applied fireproofing material.

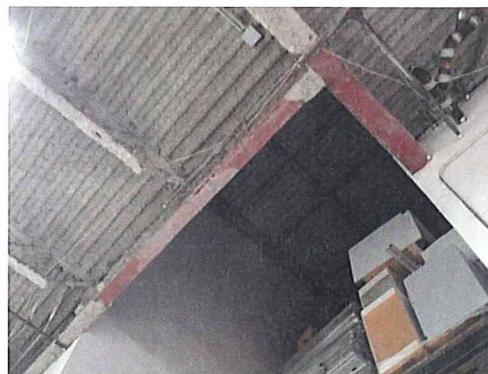
- .2 In isolated locations, fireproofing material at the underside of the second floor framing is damaged/missing. Damaged fireproofing requires immediate repair.

- Repair the areas of damaged fireproofing at the underside of the second floor framing.

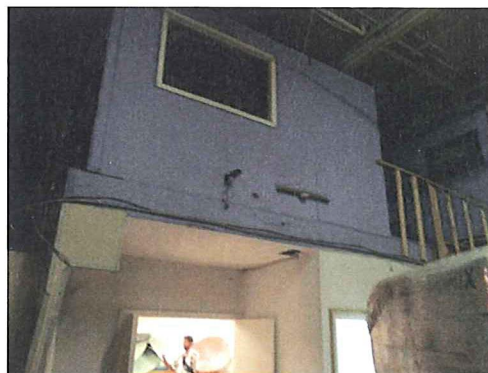
- .3 There is a mezzanine office space within the ground floor space occupied by Green Island Trading Company, at the east portion of the centre section. The mezzanine level was not accessible at the time of the site visit. The drawings provided by Toronto Building do not indicate that a Building Permit was obtained for the construction of the mezzanine. Confirmation from the tenant is required to confirm that a building permit was obtained for the construction of the mezzanine.

- Confirm with the tenant that a building permit was obtained for the construction of the mezzanine level within the space on the ground floor occupied by Green Island Trading Company (in the event that a building permit was not obtained, remove the mezzanine)

or have the mezzanine reviewed by a structural engineer and obtain a building permit for its construction).

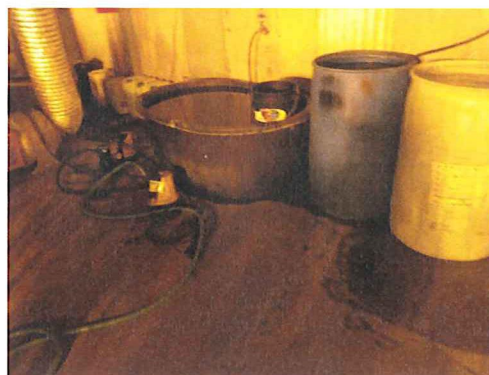
Water storage tanks are provided to each marihuana planting area. During our site visit we observed water over flows from the storage tanks and spills over the second floor and floor drains are not provided. We recommend floor drains be installed to each marihuana planting area, as required, to drain water from the floor surface.

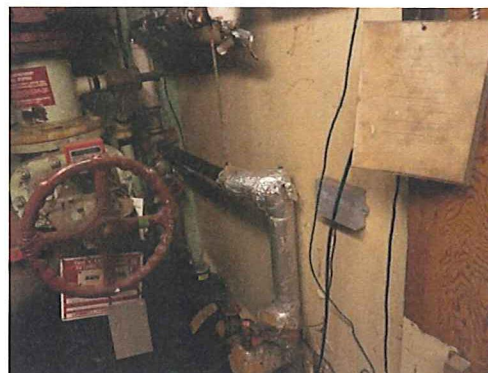
Municipal incoming water supply enters the building in the service room and is connected to a meter and three (3) shut-off valves.

Based on our visual review it appears that there is backflow prevention provided to prevent contaminants from entering the municipal potable water system.

Due to the nature of the businesses within the building, we recommend back flow prevention be installed to the incoming water supply at each occupancy in accordance with Chapter 851 (Water Supply) of the Toronto Municipal Code. This work should be carried out in conjunction with a cross-connection survey which may identify additional areas that require protection.

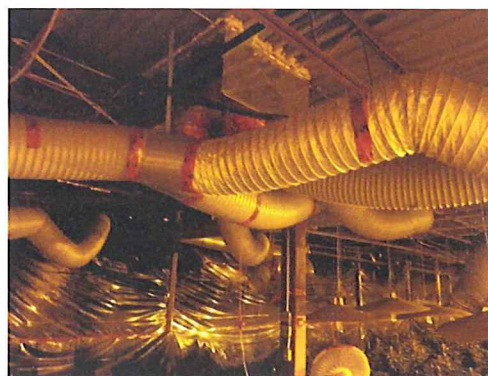
The ventilation systems within the medicinal marihuana production areas do not appear to have been carried out using good engineering practice and with the benefit of a building permit.

Article 6.2.1.1. of the Ontario Building Code details the following requirements for the design and installation of heating, ventilating and air-conditioning systems:

It should be confirmed with the tenant that a building permit was obtained for the installation of the ventilation systems. In the event that a permit was not obtained, a building permit should be obtained immediately.

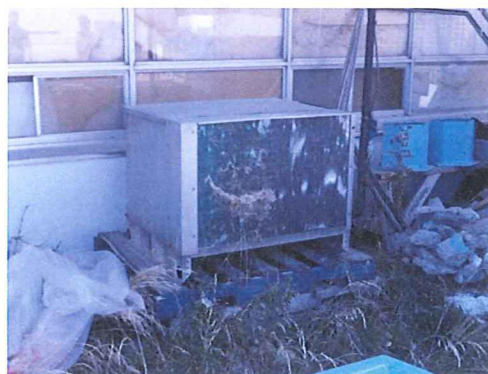
One of the outdoor condensing units that provide ventilation cooling to the medicinal marihuana production facility located on the ground floor in the east portion of the building is not professionally installed. It is mounted on a wood pallet. We recommend the outdoor condensing unit be professionally installed.

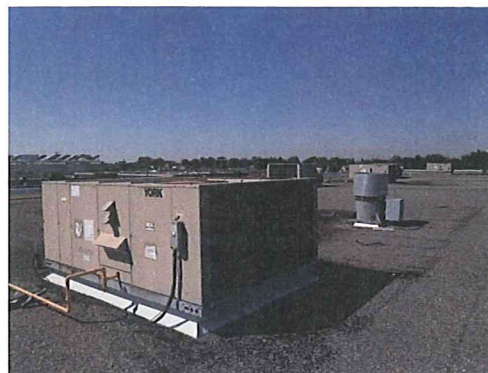
Heating and ventilation cooling to the new addition (medicinal marihuana production facility) is provided by five natural gas-fired rooftop units located on the high roof area.

The rooftop units are equipped with economizers to provide free cooling and are electrically controlled by dedicated thermostats.

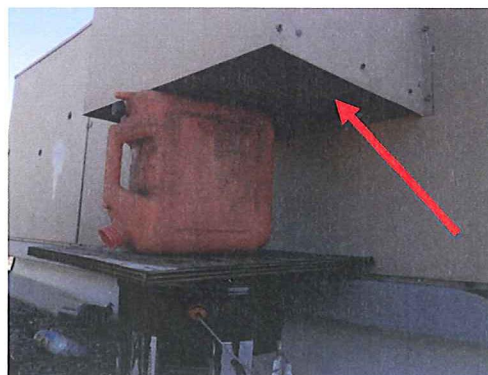
The non-functional rooftop unit's (located on the high roof area) gas supply has been disconnected and its fresh air intake has been covered with wood sheathing. This indicates that the unit's heating and cooling cycles are not working.

In our opinion, the current condition of the roof top unit serving the second floor of the Green Island Trading Company tenant space does not meet the requirements detailed in Article 629-38.A of the Toronto Municipal Code. We recommend the unit's cooling and heating cycles be restored (repaired).

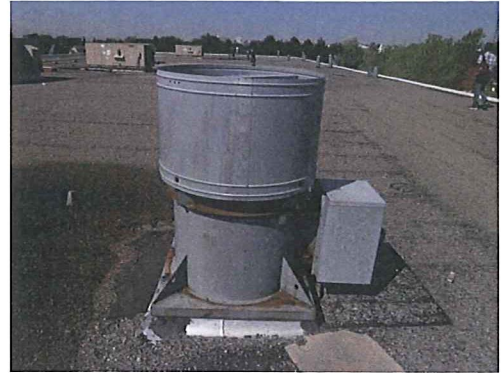
Ventilation exhaust to the medicinal marihuana production facility is provided by a rooftop mounted up-blast type exhaust fan.

The exhaust fan appears to be in working condition.

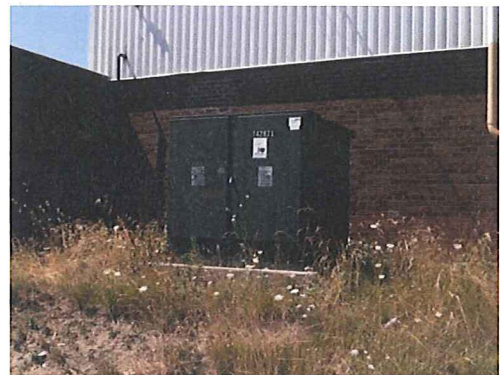
The electrical power supply is fed from a transformer mounted on a concrete housekeeping pad located outdoors.

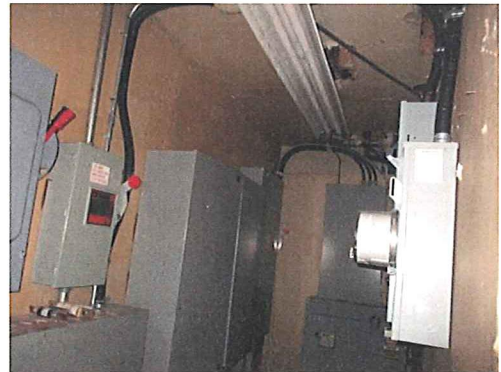
The main disconnect switch and the splitter are located in the new electrical room. The disconnect switch is manufactured by "Cutler-Hammer" and rated for 800 amperes, 600 volts, 3 phase, 4 wire.

There is another disconnect switch for the older section of the building located in the old electrical room and is rated for 600 amps.

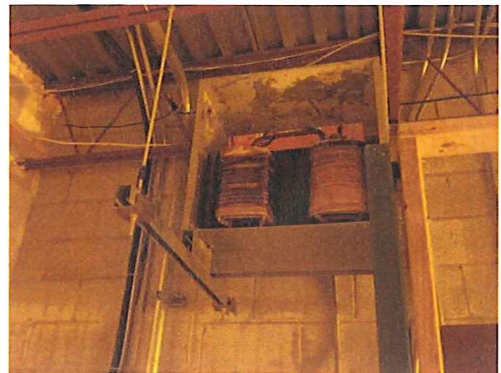
The power transformer's cover plate is missing in the medicinal marihuana production area. This condition is a potential fire and life safety hazard.
